Lubecore Technical Announcement

EPO Grease Quarantine

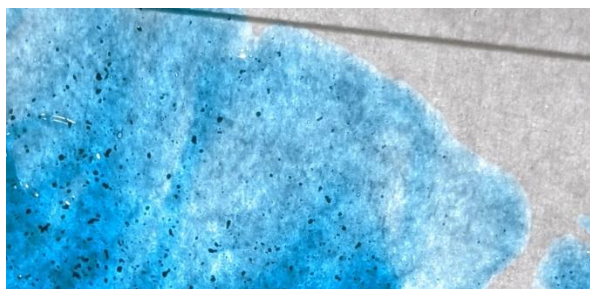
We have found a problem with the blue EPO grease that is made for Lubecore. We've found black dots suspended in the grease of a substance that is sticking preferentially to steel. This is creating in the grease the following symptoms:

- Slower flapper valve action (click can be heard from delayed flapper valve opening after the air pressure is released)
- The black material seems to collect on steel surfaces (flapper valve, inside the grease cylinder, on the spool of the injector)

Do not use any Blue EPO grease with black spots in it. An example of what this looks like is shown below. It is easiest to find these black spots by smearing a grease sample over white paper and inspecting it for spots.
