Lubecore Technical Announcement

EPO Grease

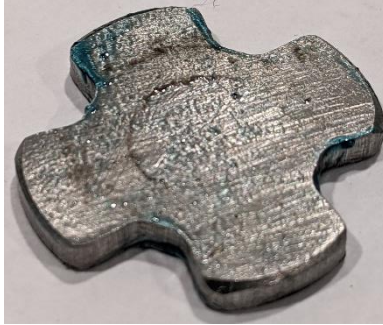
Note: Testing has verified that as soon as light blue grease is coming from the pump it will flow through the system; cleaning it such that the system will start working correctly again. The pump and injectors will be cleaned in operation. An example of a flapper valve that has been cleaned by a few pump cycles and is operating in a fully functional manner is shown below.
