Injector Assembly Error

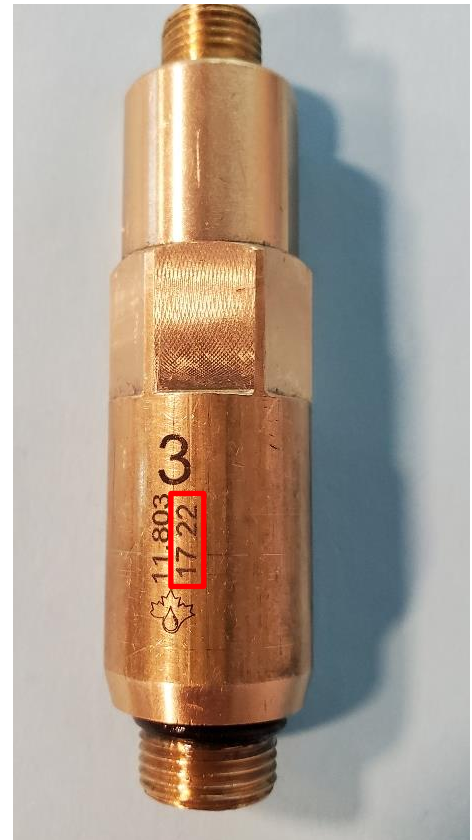
It came to Lubecore's attention that a batch of injectors were assembled incorrectly. This assembly error has been identified in Size #3 Injectors with the Serial Marking: 17 22. See the serial marker highlighted in Figure 1.

An O-ring was missed in the assembly, which allows the pump volume to bleed through a single injector.

1. Pump builds pressure but doesn't hold pressure for the duration of the cycle.
2. One or more points are receiving far too much grease.

Figure 1. Injector #3 from 17 22 Batch.

1. Remove injector(s) that over-greases. Replace with new injector.
2. Complete cycle testing to ensure that pump and system exhibits normal pressure cycle behaviour.
3. Notify Lubecore International for replacement of injector(s).
