EPO Pump Series C1049 Not Coming Off Pressure

To : Recipients & Distributors

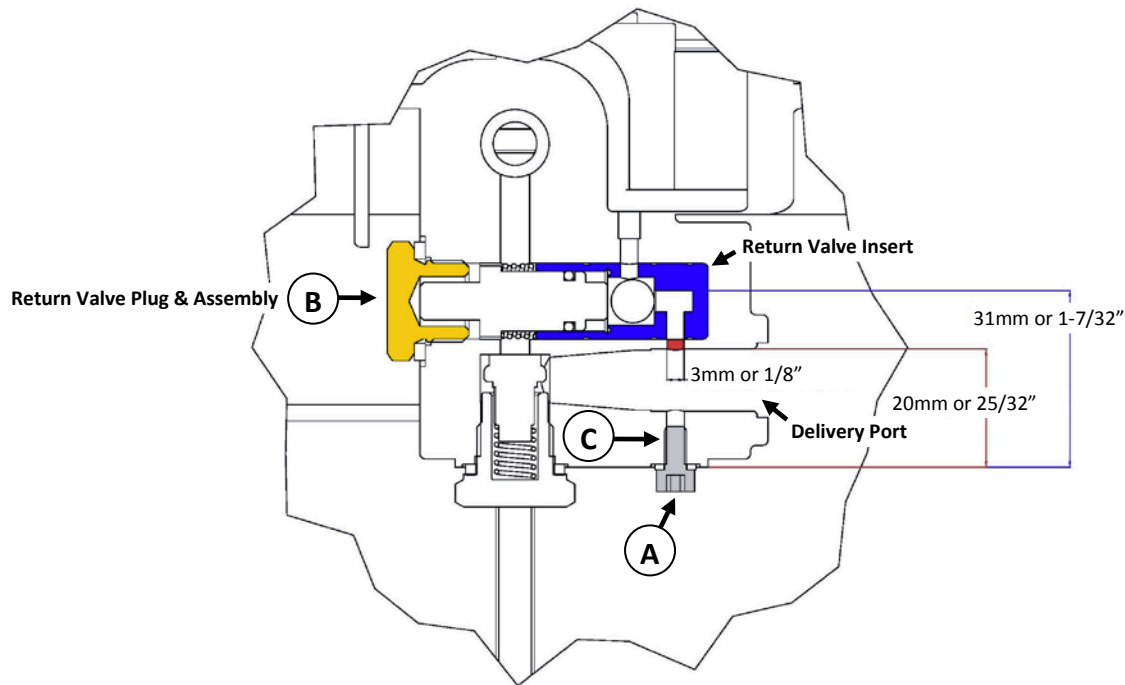
EPO Pump frontal cut away

Recently two EPO Pneumatic pumps, serial number: 321 0000 C1049-035 and 321 0000 C1049-038 were observed not coming off pressure during installation tests. It was determined that during manufacture an internal gallery had not been completely drilled through the pump body to allow grease to pass through the return valve insert.

Remove the 3mm Allen head screw (A) and insert a 1.5mm Allen Key into the gallery opening until it bottoms out. Clamp the Allen Key using your thumb and withdraw it from the gallery. Measure the distance from your thumb nail to the end of the Allen Key. If the depth is 20mm or less, the internal gallery has not been drilled through.

Remove the "return valve plug" (B) and valve, place these in a clean bag to ensure they are not lost or contaminated, then using a pen magnet remove the "return valve ball" from the "return valve insert". Using a 7/64" drill bit inserted into "cross drill port" (C) drill a hole through the pump housing and into the return valve chamber. Remove mainline fitting from pump housing and manually cycle pump 3 times to clear the pump of any metal fillings. Reassemble and follow system pressure test procedure.
