Lubecore Communication

Subject: Fitting Problem 21.113, 21.114, 21.229 and 21.230

Date: August 28, 2013

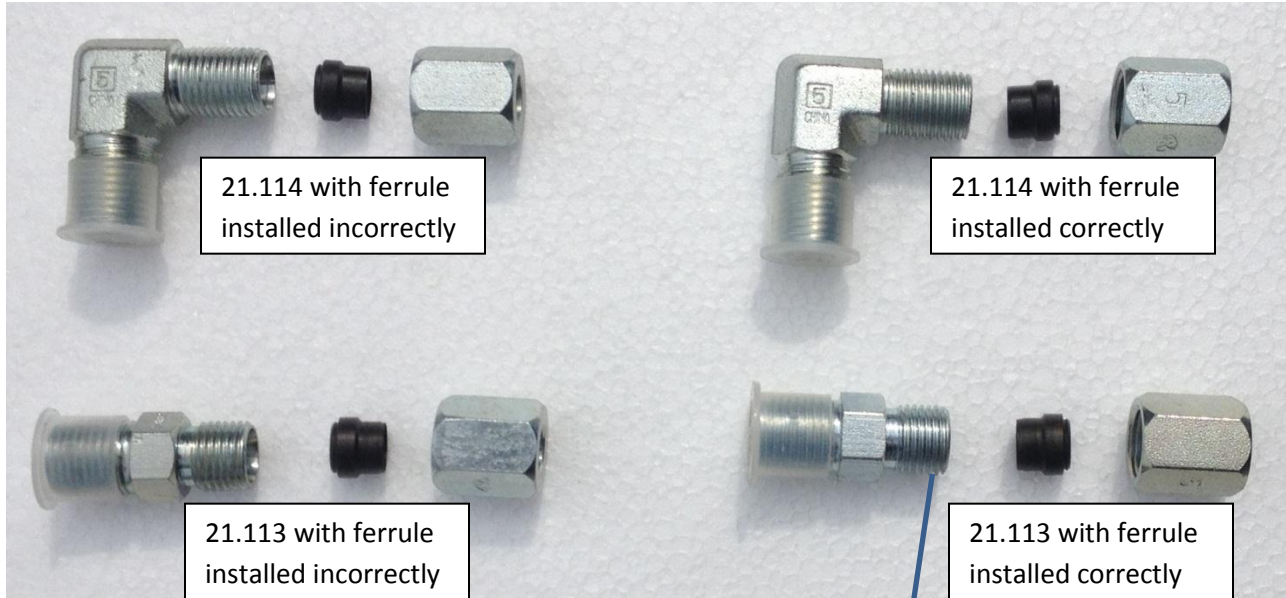
We have found that one of our suppliers has not been supplying our range of 8mm steel compression tube fittings: 21.113, 21.114, 21.229, 21.230 with the olive (ferrule) set properly. This has resulted in a few reported failures in the field. To immediately correct this issue, Lubecore will be addressing the concern with our supplier as well as checking all of our current inventory to ensure all product being shipped out is set in the fitting in the proper position.

Picture of fittings showing proper and improper direction of ferrule before installation.

1. For those whose shipment is in transit or who have not installed a pump system you have in stock – Take the nut off steel compression fitting and ensure that the olive is set in the fitting properly – see image below.
2. Before reassembling the fitting, we recommend that you lubricate the thread on the olive side – this will allow the compression to be completed with less effort.
3. Insert your tubing through the fitting and olive.
4. Use two wrenches to tighten the fitting until the olive is properly set.

Lubricate this thread before re-assembling.
This will allow the compression to be
completed with less effort.
