## Lubecore Technical Announcement

### Heavy Duty Banjo Fitting

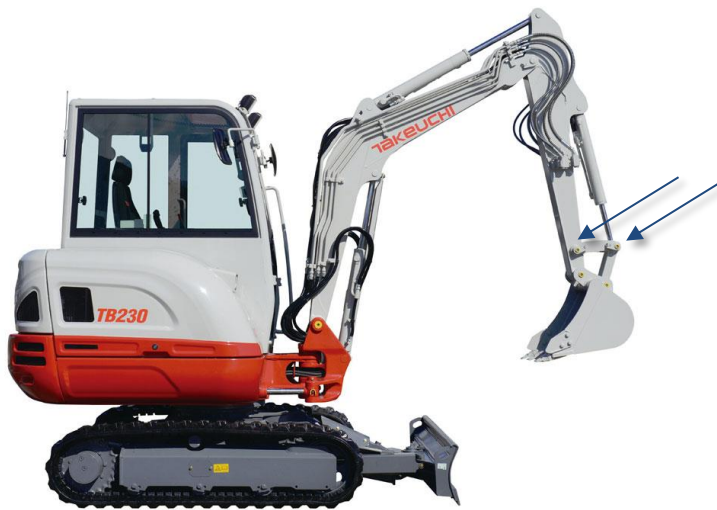
*Figure 1: Fitting Location*

Lubecore is pleased to announce the new 20.329 Heavy Duty Banjo Fitting. This fitting was designed to be installed at bucket pin locations as shown in Figure 1, and can be used in other similar locations.

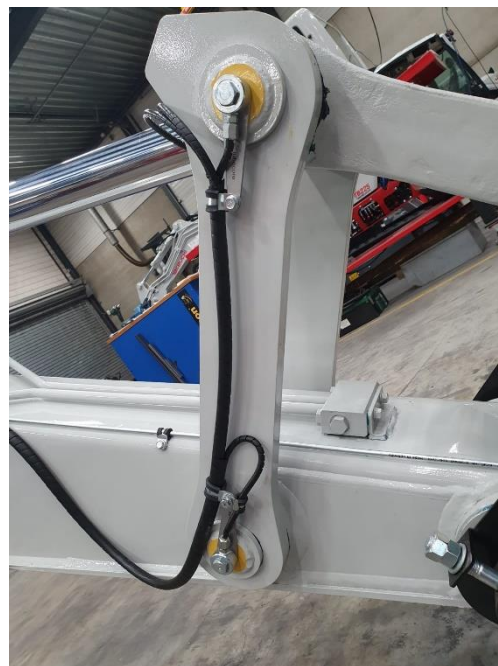
*Figure 2: Installed Heavy-duty Banjos*

An installed set of heavy-duty banjos on a Takeuchi Mini-Excavator is shown in Figure 2. Note the brackets included in the installed oriented along the side links which allow a tidy install with p-clamps holding the secondary lining. Heavy-duty banjos eliminate protection rings from an install. No need to grind, weld or paint! This is a significant time saver, making installations more profitable.

Line routing brackets (Figure 2) have also been designed to simplify line routing at the H link side arm. The bracket part number is 40.143 and is shown in Figure 4. The large hole in the bracket interfaces with the banjo, and the small hole features an M6X1 thread for securing a p-clamp.

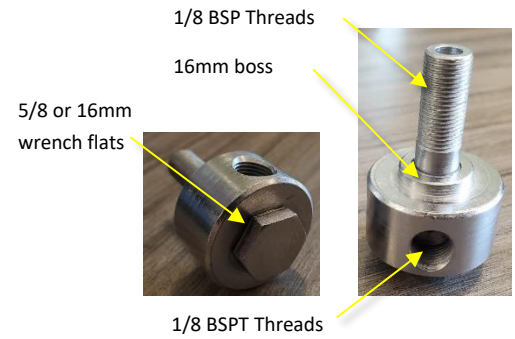
Figure 3: Banjo Fitting (20.239)

In order for these banjo fittings to withstand the harsh conditions present at the bucket end of excavation equipment the fitting is designed to have a shear boss that fits into the pilot hole at the bucket grease point. The shear boss is smaller than other construction banjo fittings available on the market to fit smaller excavators like the Takeuchi TB series. Current market offerings have bosses with 20mm diameters, where this new 20.329 features a 16mm diameter. Lubecore designed the 1/8 BSP threads of this banjo fitting to be long enough to reach the grease point interface threads without the need to use additional adapter fittings between the banjo fitting and the recessed grease point. The grease line interface features 1/8 BSPT threads. The wrench flats are designed to work with a 5/8 or 16mm wrench.
