12.015 – LC Timer Connector Crimps

12.015 – 10Vdc - 30Vdc Truck Timer

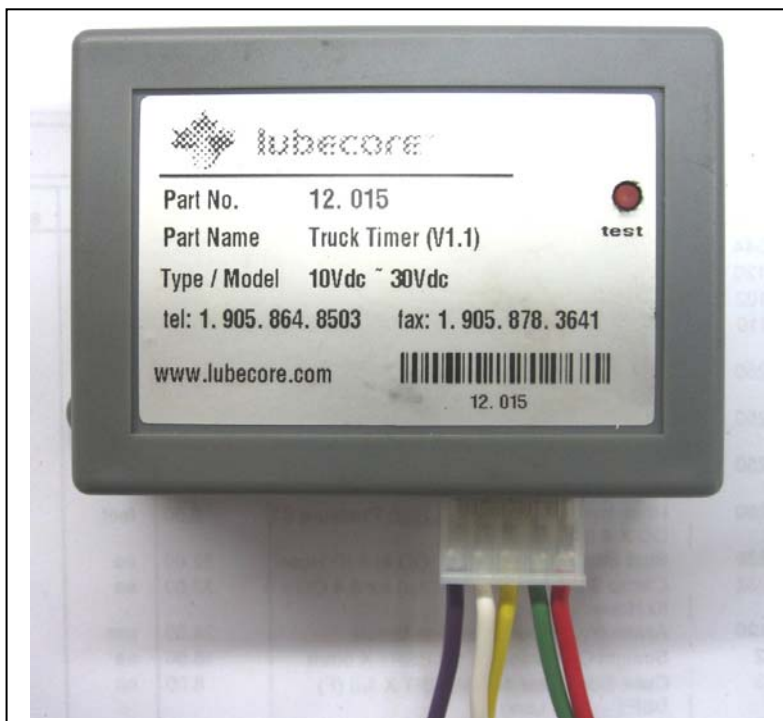
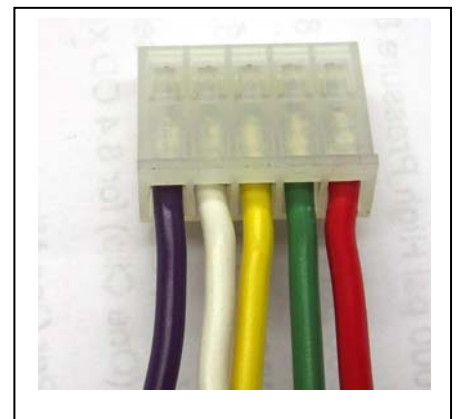
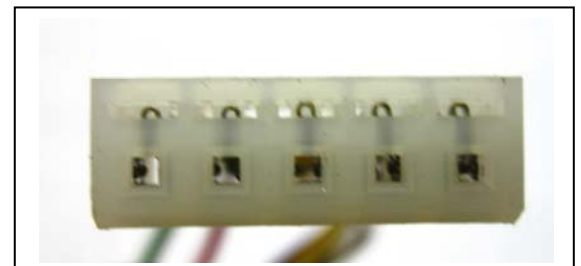
We've had reports of a loose connection on the main connector on the gray Lubecore timer (LCT Timer). For units installed between August 2011 and Oct 2011, please inspect for proper crimping and insertion of terminals. We ask that during your normal PM check, you pay special attention to this. Pushing the red button should result in the system doing a single cycle. Please do this as well as giving the connector a close look, and performing a quick physical check of the connections by giving each wire a tug to ensure proper crimp and insertion. Also, please ensure that timers are mounted where they will not be in harm's way, i.e. somewhere they won't be kicked and/or get wet.
