Lubecore Communication

Subject: Changing out the EP-2 Pneumatic Pump Flapper Valve

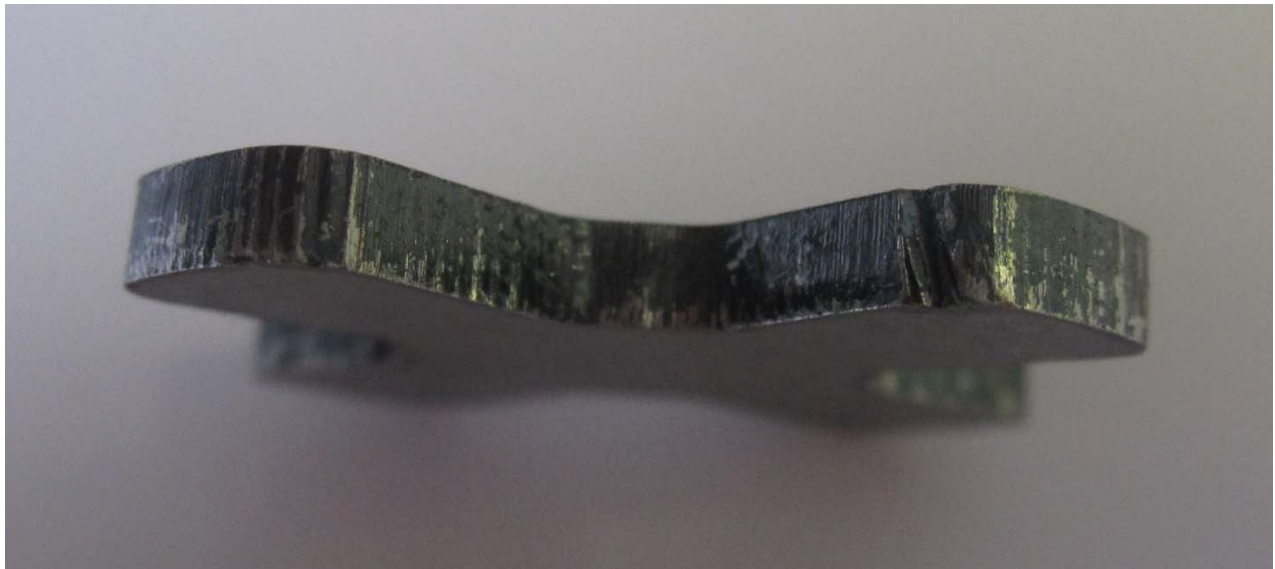
Original

The flappers themselves are virtually identical – the ones to be replaced are slightly smaller dimensionally and look a little rougher around the laser cut edges. The replacement flappers are slightly larger and have a better finish. As always, the finished side seats against inlet.

If you let us know how many pumps you have on the shelf, and we'll send replacement flapper valves to you.

All new pumps, starting with SN C13xx will have the improved flapper installed.

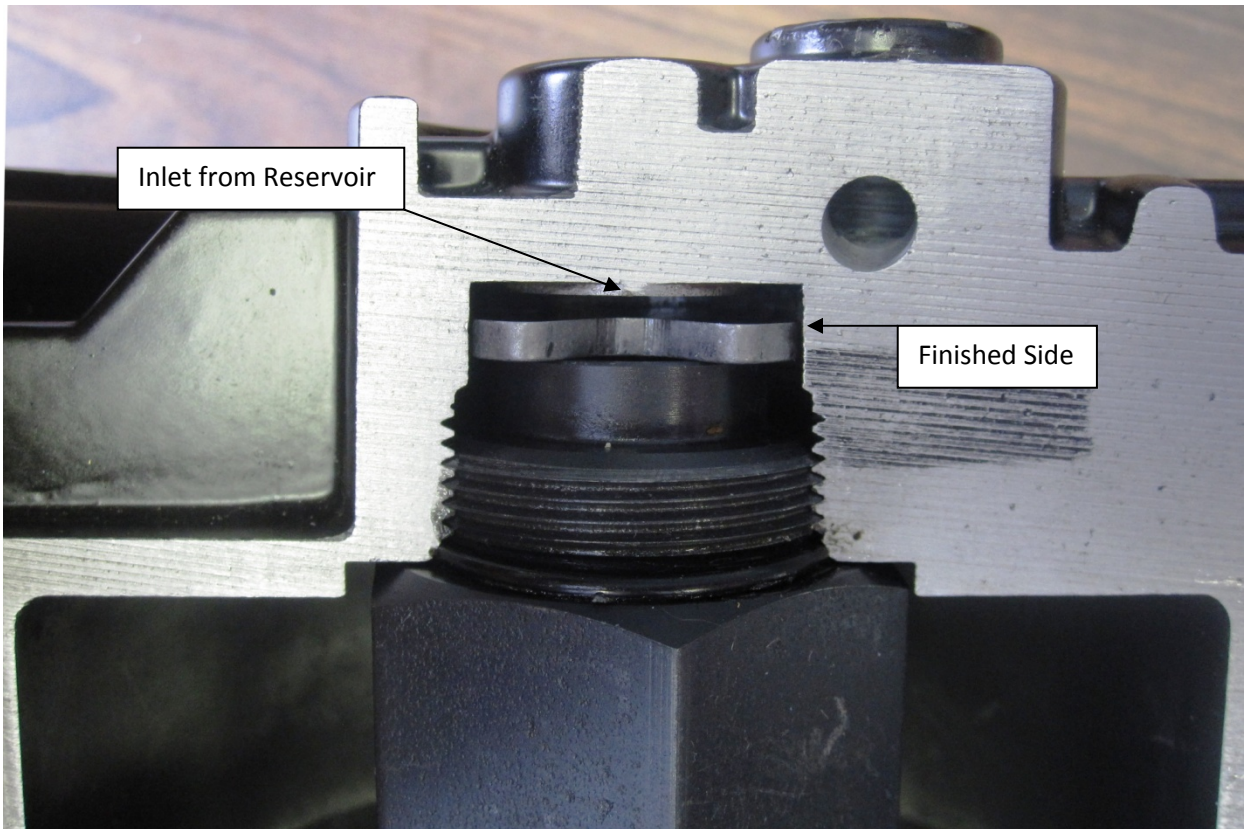
Cutaway of pump showing flapper valve in place
