Lubecore Technical Announcement

EPO Grease

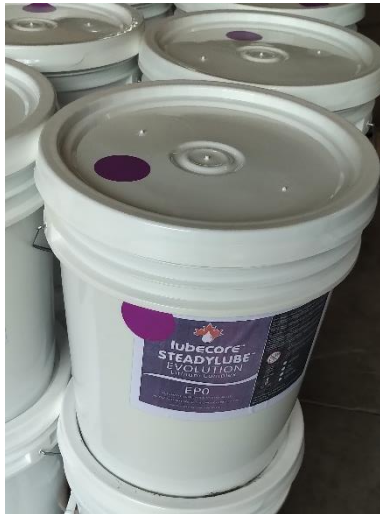
Note: Our supplier informed us that it is unlikely that the Treated Grease will separate during periods of storage, however they recommend it should be stirred prior to each use. Our supplier has also informed us that the treated grease has similar lubricating properties as regular Lubecore EPO grease and will not cause damage to any system materials.

- 4. Fill the pump full with Lubecore Treated Grease – This will be marked on pails with a purple sticker (see above)
 - a. If Front Mount Timer equipped system:
